**PHOTO  
INTERPRETATION  
NOTE**

**RECONSTRUCTION, HAI PHONG CEMENT PLANT  
NORTH VIETNAM**

**NPIC/R-47 /71**

**NOVEMBER 1971**

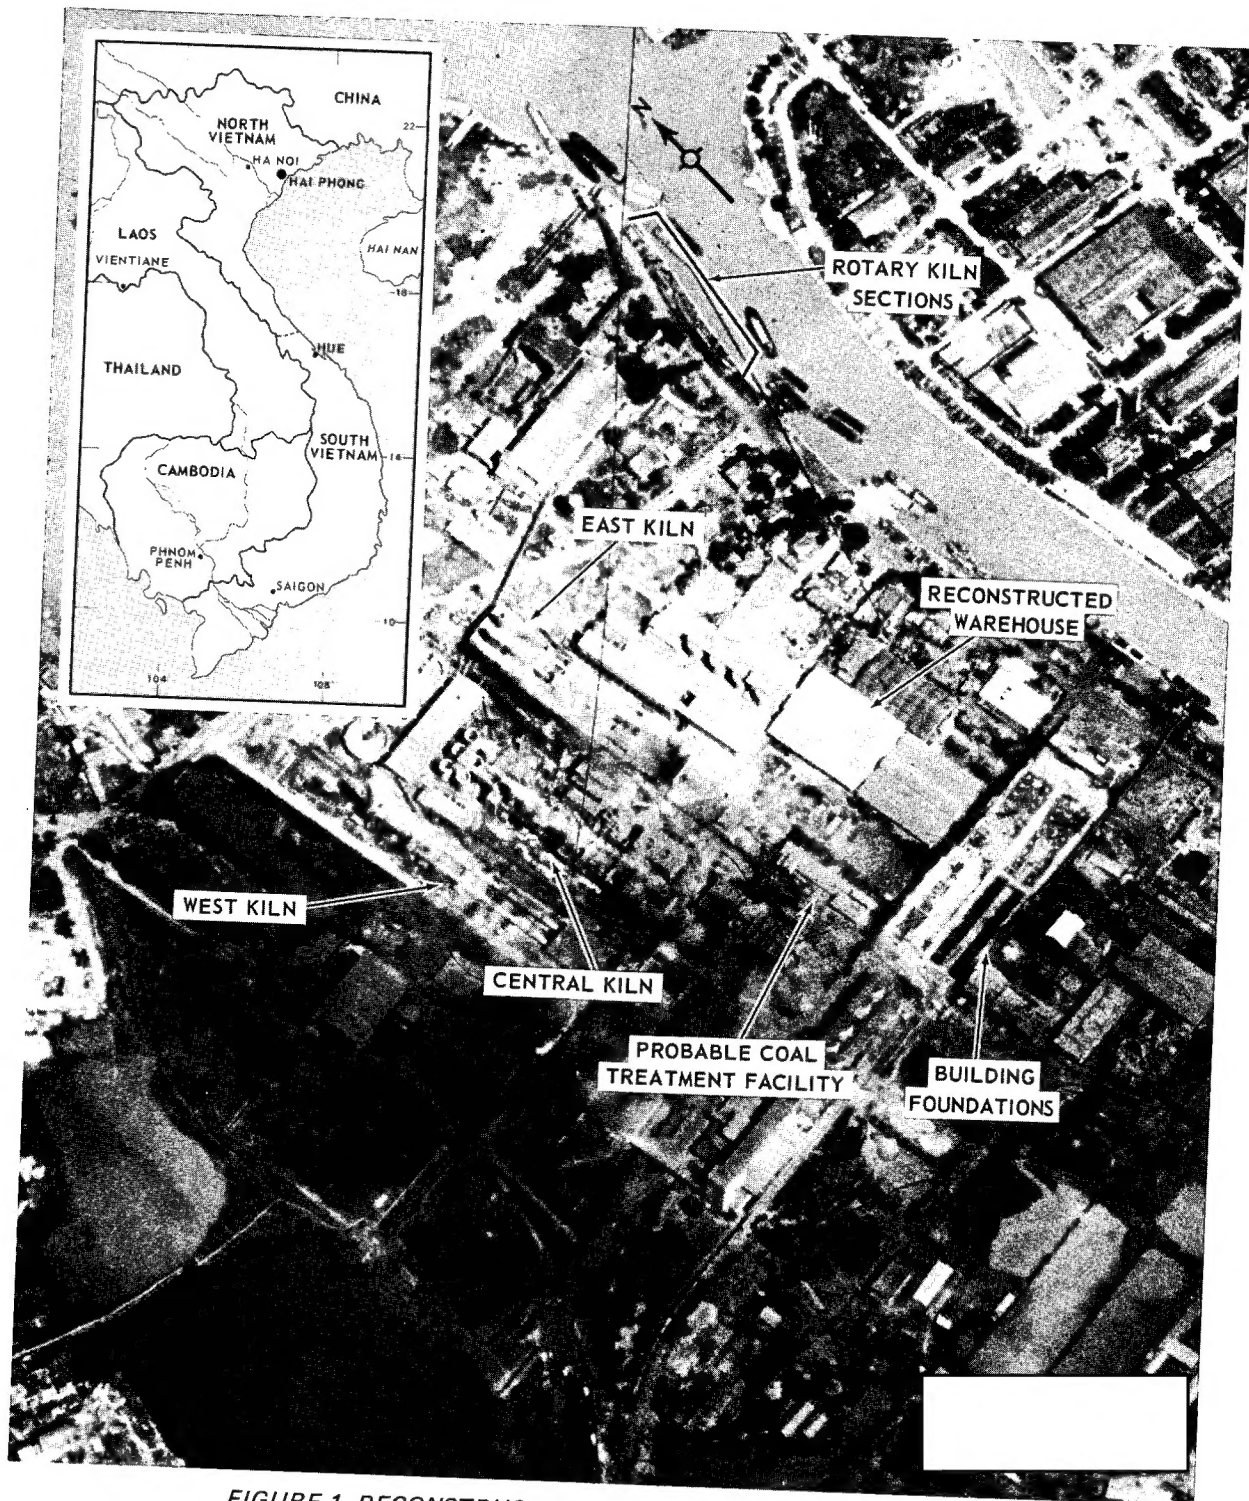
FIGURE 1. RECONSTRUCTION AT HAIPHONG CEMENT PLANT

1. The Haiphong Cement Plant, severely damaged by airstrikes in April 1967, has been almost completely rebuilt. Six of the original seven horizontal rotary kilns were operational

2. Operations at the plant had been entirely stopped because of extensive damage. One of three rotary kiln buildings was destroyed, one was heavily damaged, and the other sustained minor damage. Two clinker storage buildings were heavily damaged and one moderately damaged. The coal treatment plant, the limestone crushing building, several warehouses, and numerous support buildings were moderately to heavily damaged.

3. Reconstruction of the plant has been slow. One kiln of the westernmost kiln building was repaired and operational [REDACTED] This was the first indication of renewed production at the plant. The second kiln of this two-kiln unit was subsequently operational. [REDACTED] all three kilns of the easternmost kiln building were rebuilt and operating. [REDACTED] smoke was coming from the stack of the central kiln building. One of the two kilns of this unit has been repaired and the other has been removed, possibly in preparation for replacement or repair. Thirteen kiln sections were on the transshipment quay to the east of the plant.

4. Other recent reconstruction included the addition of a new probable coal treatment plant, replacement of a previously destroyed large warehouse, and replacement of the damaged roof of the eastern clinker storage building. Foundations for additional new buildings indicated continuing construction at the facility.
